1. AGENCY USE ONLY (Leave blank)		2. REPORT DATE 09/00/55	3. REPORT TYPE AND DATES COVERED	
4. TITLE AND SUBTITLE REPORT ON GROUNDWATER CONTAMINATION, ROCKY MOUNTAIN ARSENAL, DENVER, COLORADO			5. FUNDING NUMBERS

GROUND WATER CONTAMINATION

CORPS OF ENGINEERS, U. S. ARMY
OFFICE OF THE DISTRICT ENGINEER
OMAHA DISTRICT
OMAHA, NEBRASKA
SEPTEMBER 1955

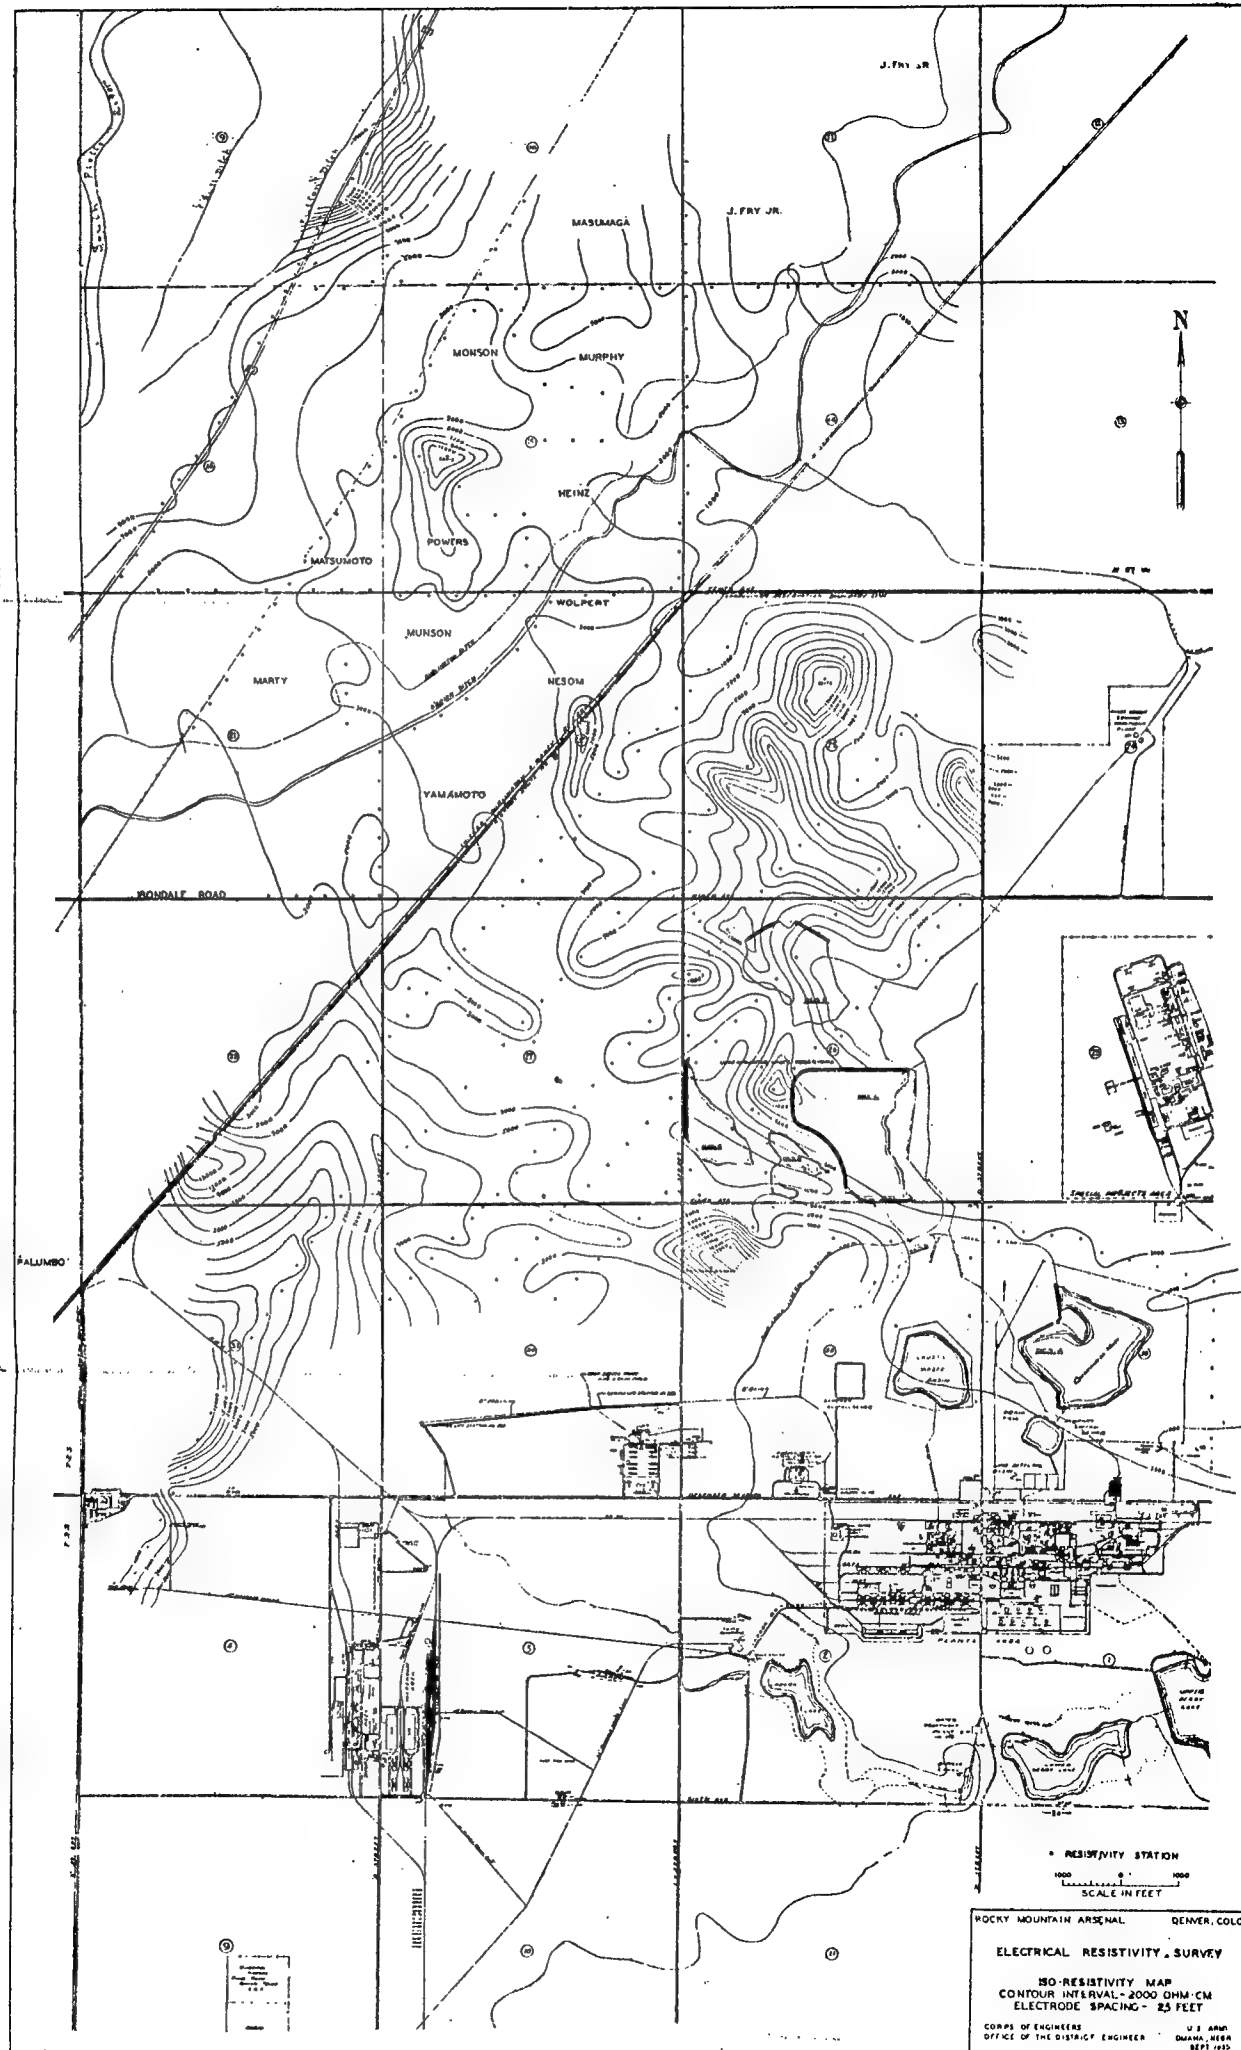
ROCKY MOUNTAIN ARSENAL DENVER, COLO.
 ELECTRICAL RESISTIVITY SURVEY
 150-RESISTIVITY MAP
 CONTOUR INTERVAL - 2000 OHM-CM
 ELECTRODE SPACING - 25 FEET
 CORPS OF ENGINEERS U.S. ARMY
 OFFICE OF THE DISTRICT ENGINEER DENVER, COLO.
 SEPT 1955

The electrical resistivity survey revealed two areas which have pronounced low resistivity values. The general trend of these "low" areas is in a northwest direction. The limits of the "low" area near the northern boundary line have not been delineated as thoroughly as the "low" area northwest of the Contaminated Waste Reservoir A. It may be noted that the "low" areas follow a trend toward the area being contaminated, namely the Powers property, as shown on the iso-resistivity maps, Plates Nos. 2, 3, 4, and 5.
